Read Before Installing MPE/iX Release 7.0 (C.70.00)

HP e3000 MPE/iX Computer Systems

Manufacturing Part Number: 30216-90313

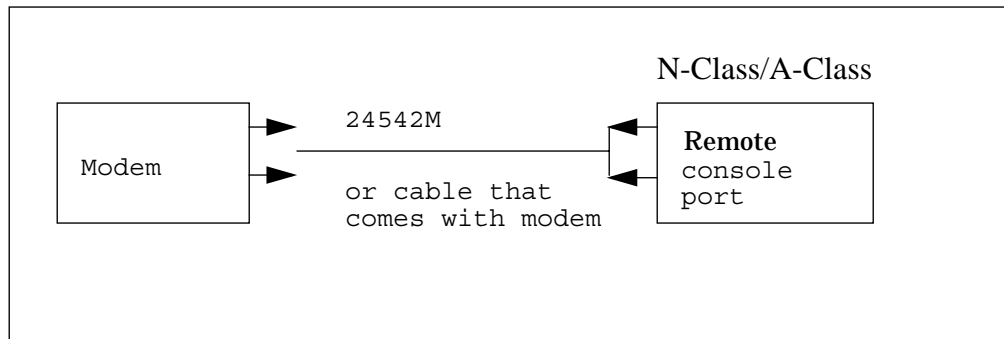
The modem that is supported on the Remote console port on the N-Class and A-Class systems is the MultiTech Model MT5634ZBA (HP part No: 0960-1074).

The physical connection is:

The cable is connected to the 9 pin Remote Console Serial port on the core I/O card. Connect the modem to the system and to the phone line. Make sure the modem is connected to the AC power and is turned on. There is a small switch on the side of the modem.
